## Vibration Monitoring Report No.1 (19/8/2022 – 2/10/2022) Proposed Residential Unit Development 89 John Whiteway Drive, Gosford NSW

Deircorp Pty Ltd (the Client) engaged EI Australia to carry out Vibration Monitoring (VM) for the proposed development at 89 John Whiteway Drive, Gosford NSW (the site). The purpose of the monitoring is to monitor the vibration induced during construction. Vibration monitoring is undertaken continuously and will be used to guide the earthworks contractor during construction.

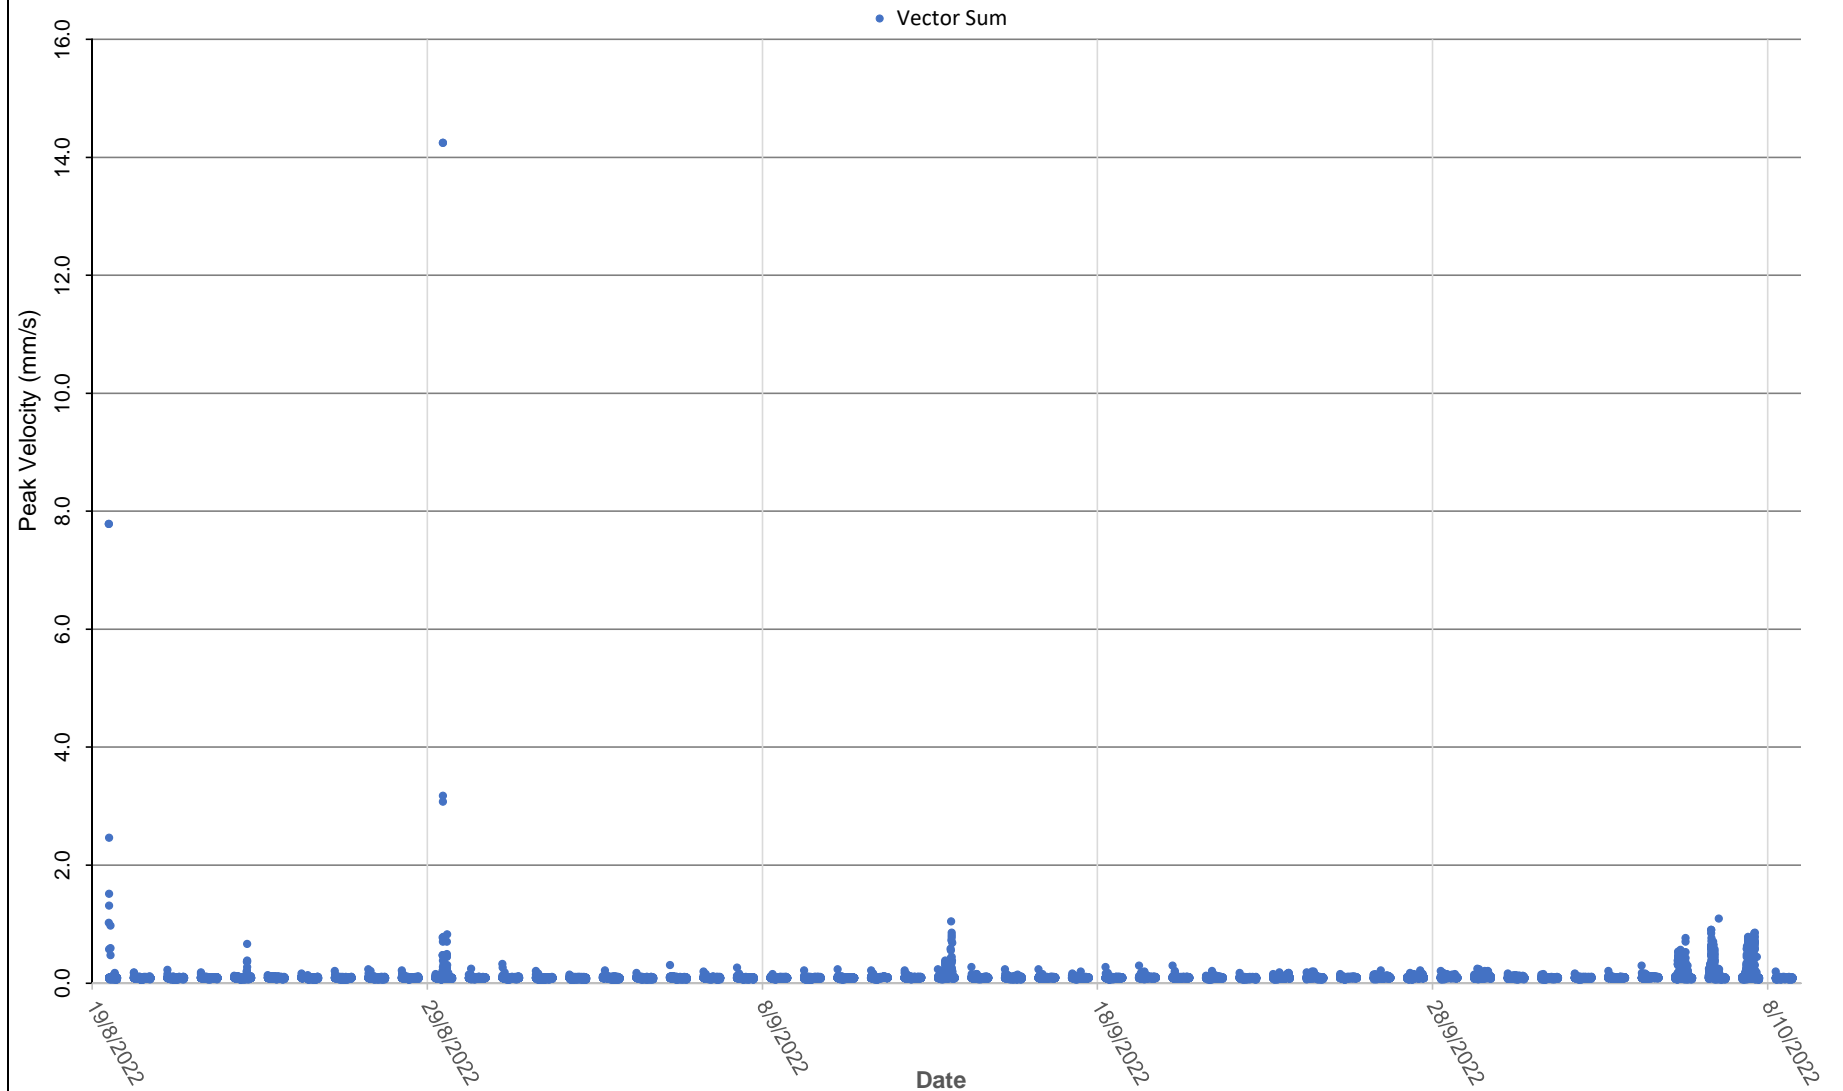
**2.1**

- VM1: 0 out of 30,822 recorded events exceeded the threshold for residential / commercial buildings.
- VM2: 2 out of 33,246 recorded events exceeded the threshold for residential / commercial buildings.
- VM3: 0 out of 32,436 recorded events exceeded the threshold for residential / commercial buildings.
- VM4: 0 out of 22,876 recorded events exceeded the threshold for residential / commercial buildings.
- VM5: 0 out of 30,112 recorded events exceeded the threshold for residential / commercial buildings.

Considering the isolated number of exceedance events compared to the number of recorded events, EI is of the opinion that the exceedance events is not likely to have any adverse impact on the surrounding building structures.
