## Vibration Monitoring Report No.2 (8/10/2022 – 30/10/2022) Proposed Residential Unit Development 89 John Whiteway Drive, Gosford NSW

Deicorp Pty Ltd (the Client) engaged El Australia to carry out Vibration Monitoring (VM) for the proposed development at 89 John Whiteway Drive, Gosford NSW (the site). The purpose of the monitoring is to monitor the vibration induced during construction. Vibration monitoring is undertaken continuously and will be used to guide the earthworks contractor during construction.

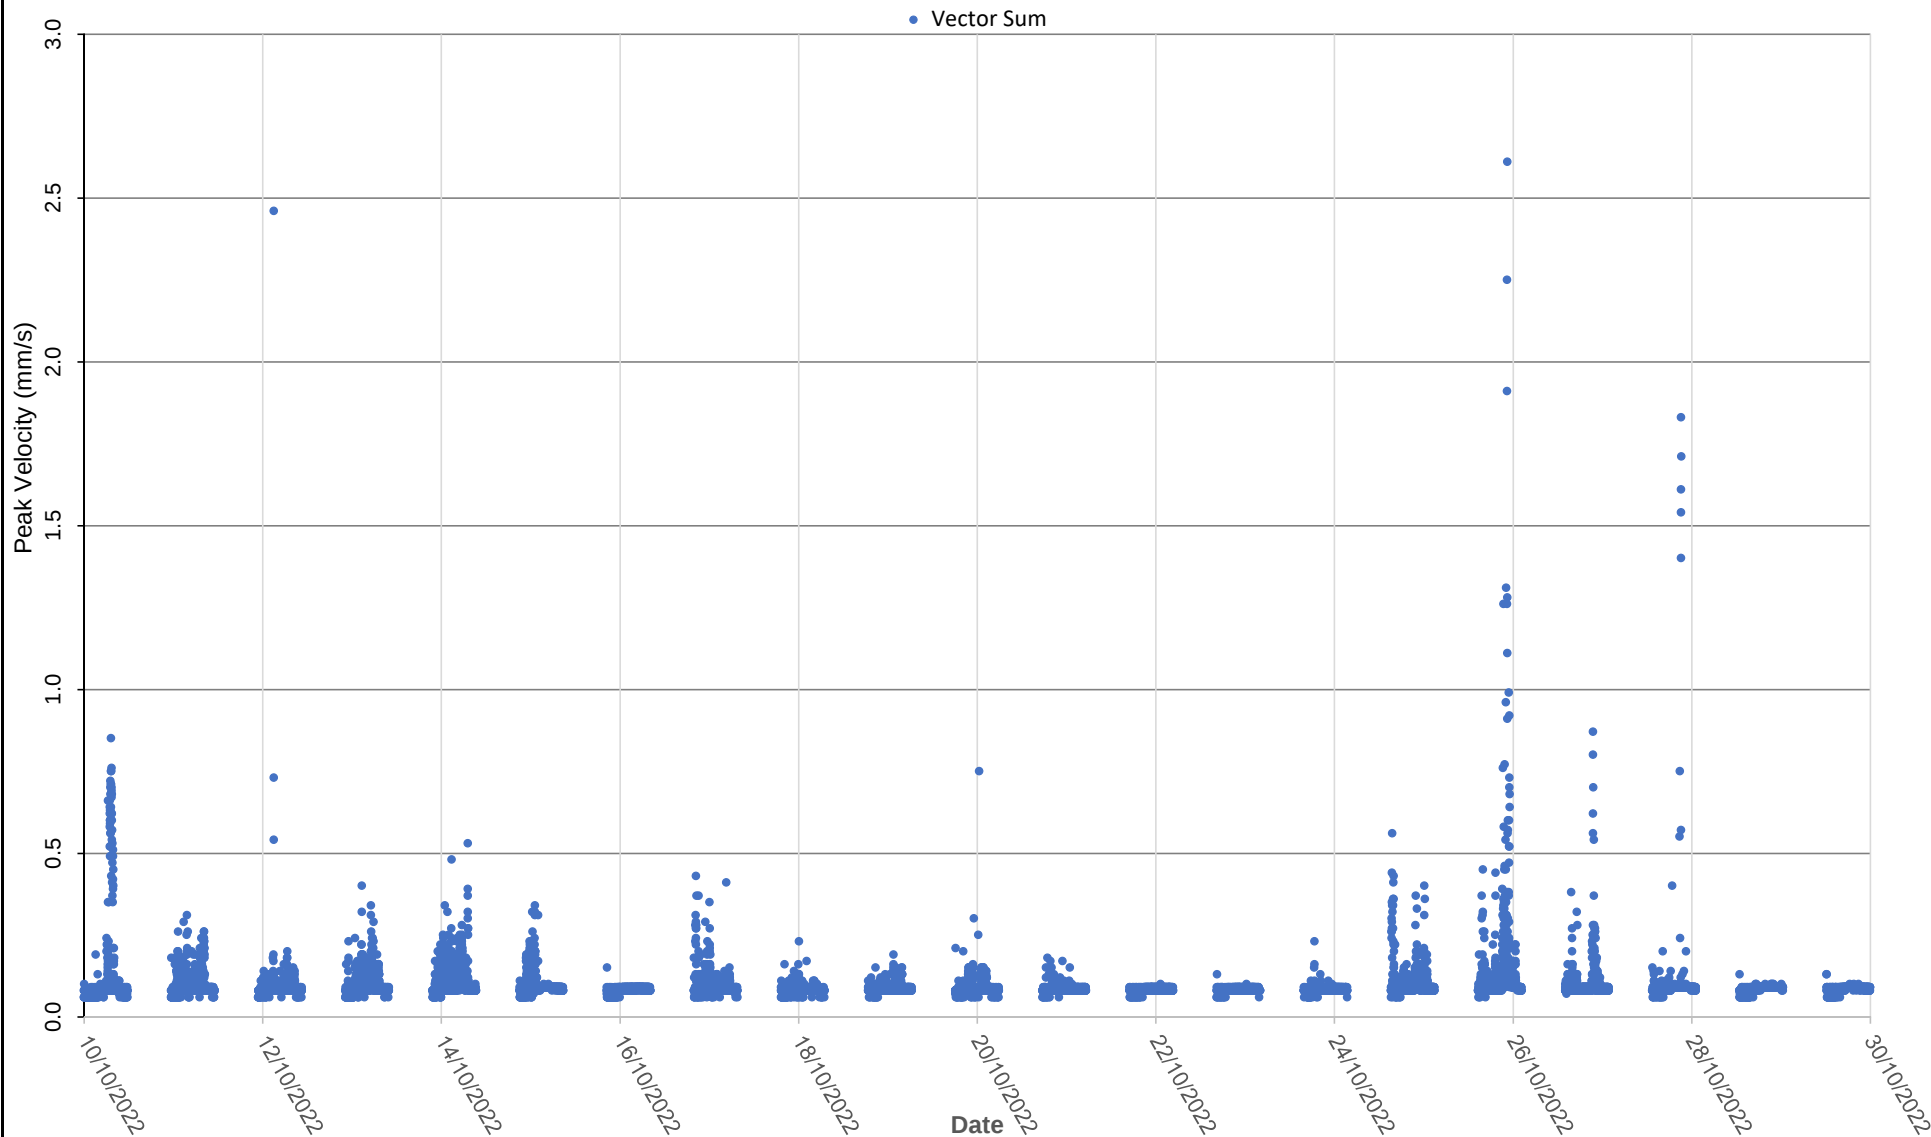
**1.1**

- VM1: 0 out of 15,080 recorded events exceeded the threshold for residential / commercial buildings.
- VM2: 0 out of 13,066 recorded events exceeded the threshold for residential / commercial buildings.
- VM3: No data.
- VM4: 0 out of 15,089 recorded events exceeded the threshold for residential / commercial buildings.
- VM5: 0 out of 12,899 recorded events exceeded the threshold for residential / commercial buildings.
