Vibration Monitoring Report No.3 (31/10/2022 – 4/12/2022) Proposed Residential Unit Development 89 John Whiteway Drive, Gosford NSW

Project: E25639.G11

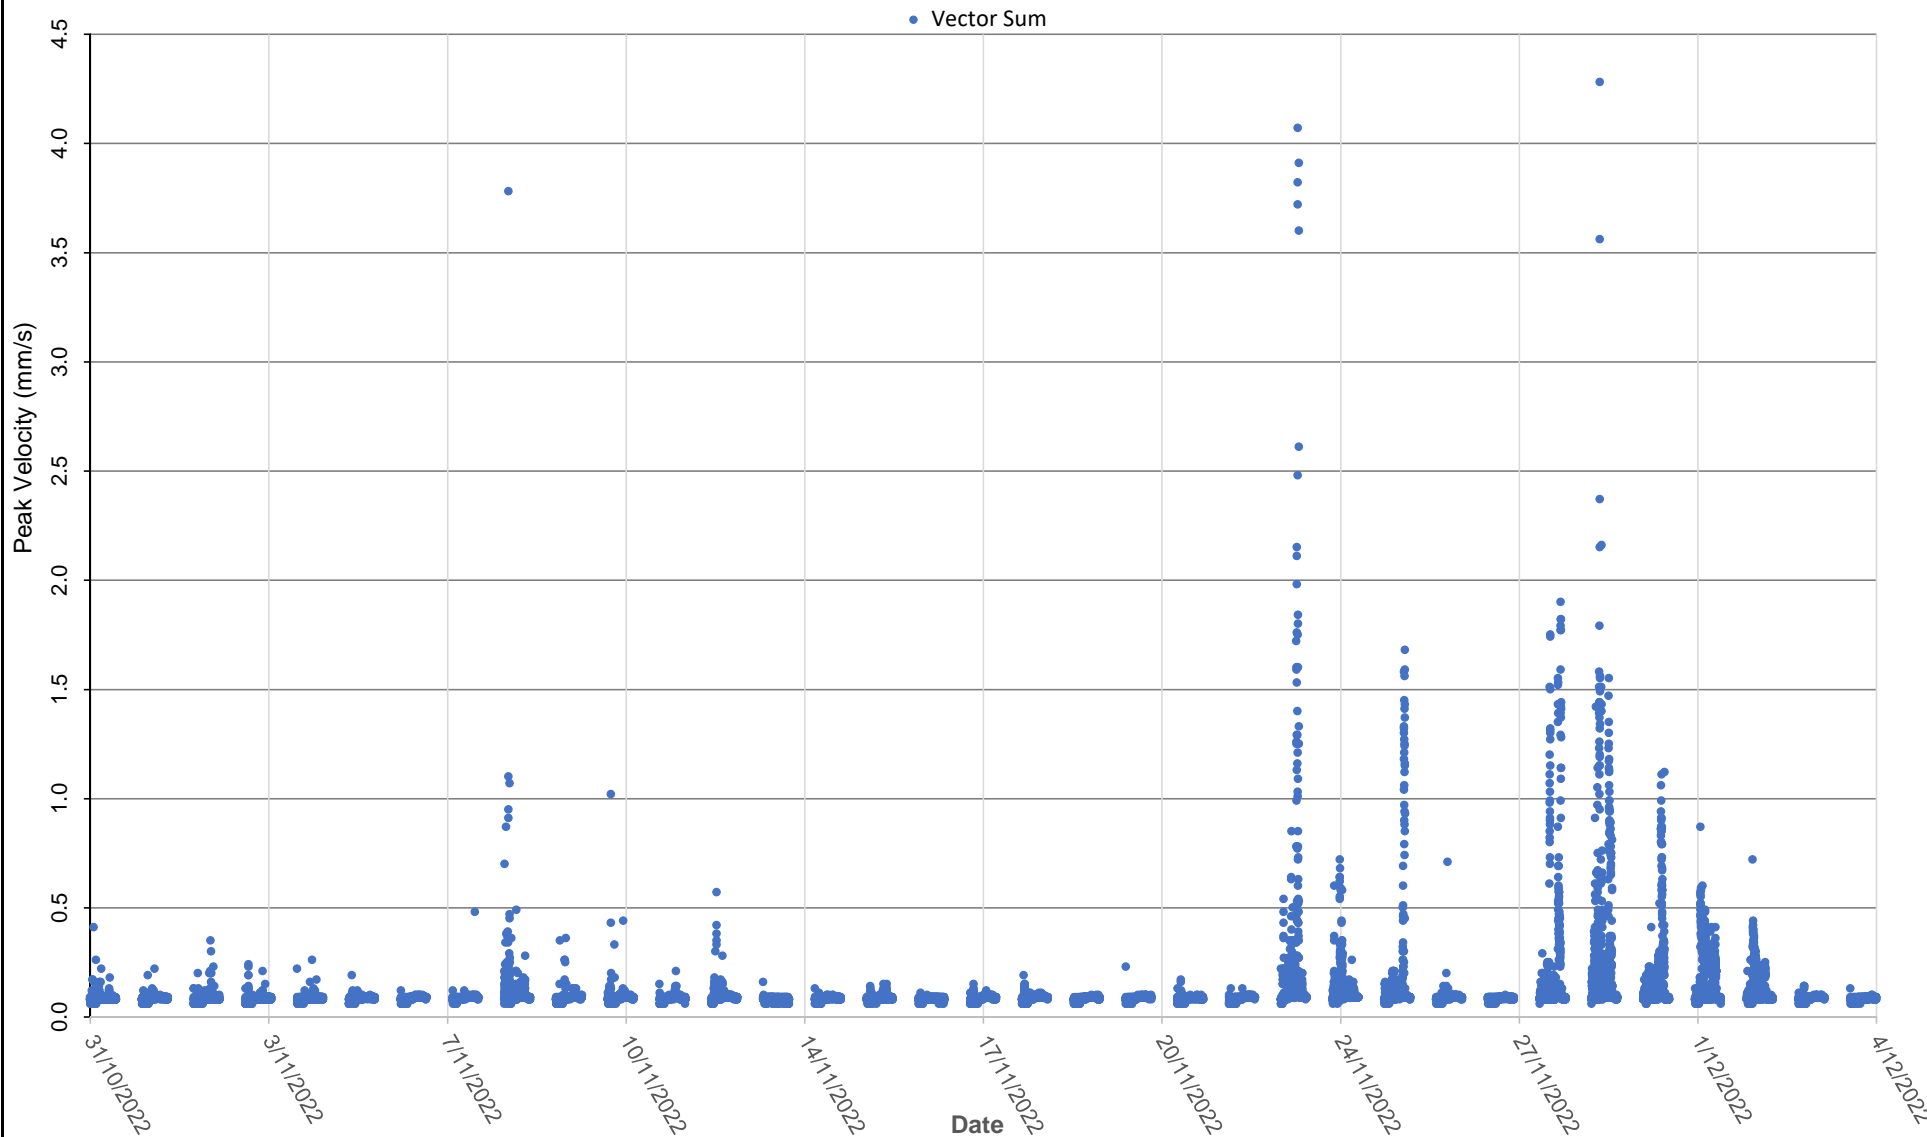
1.1

- VM1: 0 out of 25,116 recorded events exceeded the threshold for residential / commercial buildings.
- VM2: 0 out of 25,181 recorded events exceeded the threshold for residential / commercial buildings.
- VM3: 0 out of 21,948 recorded events exceeded the threshold for residential / commercial buildings.
- VM4: 0 out of 25,110 recorded events exceeded the threshold for residential / commercial buildings.
- VM5: 0 out of 25,123 recorded events exceeded the threshold for residential / commercial buildings.

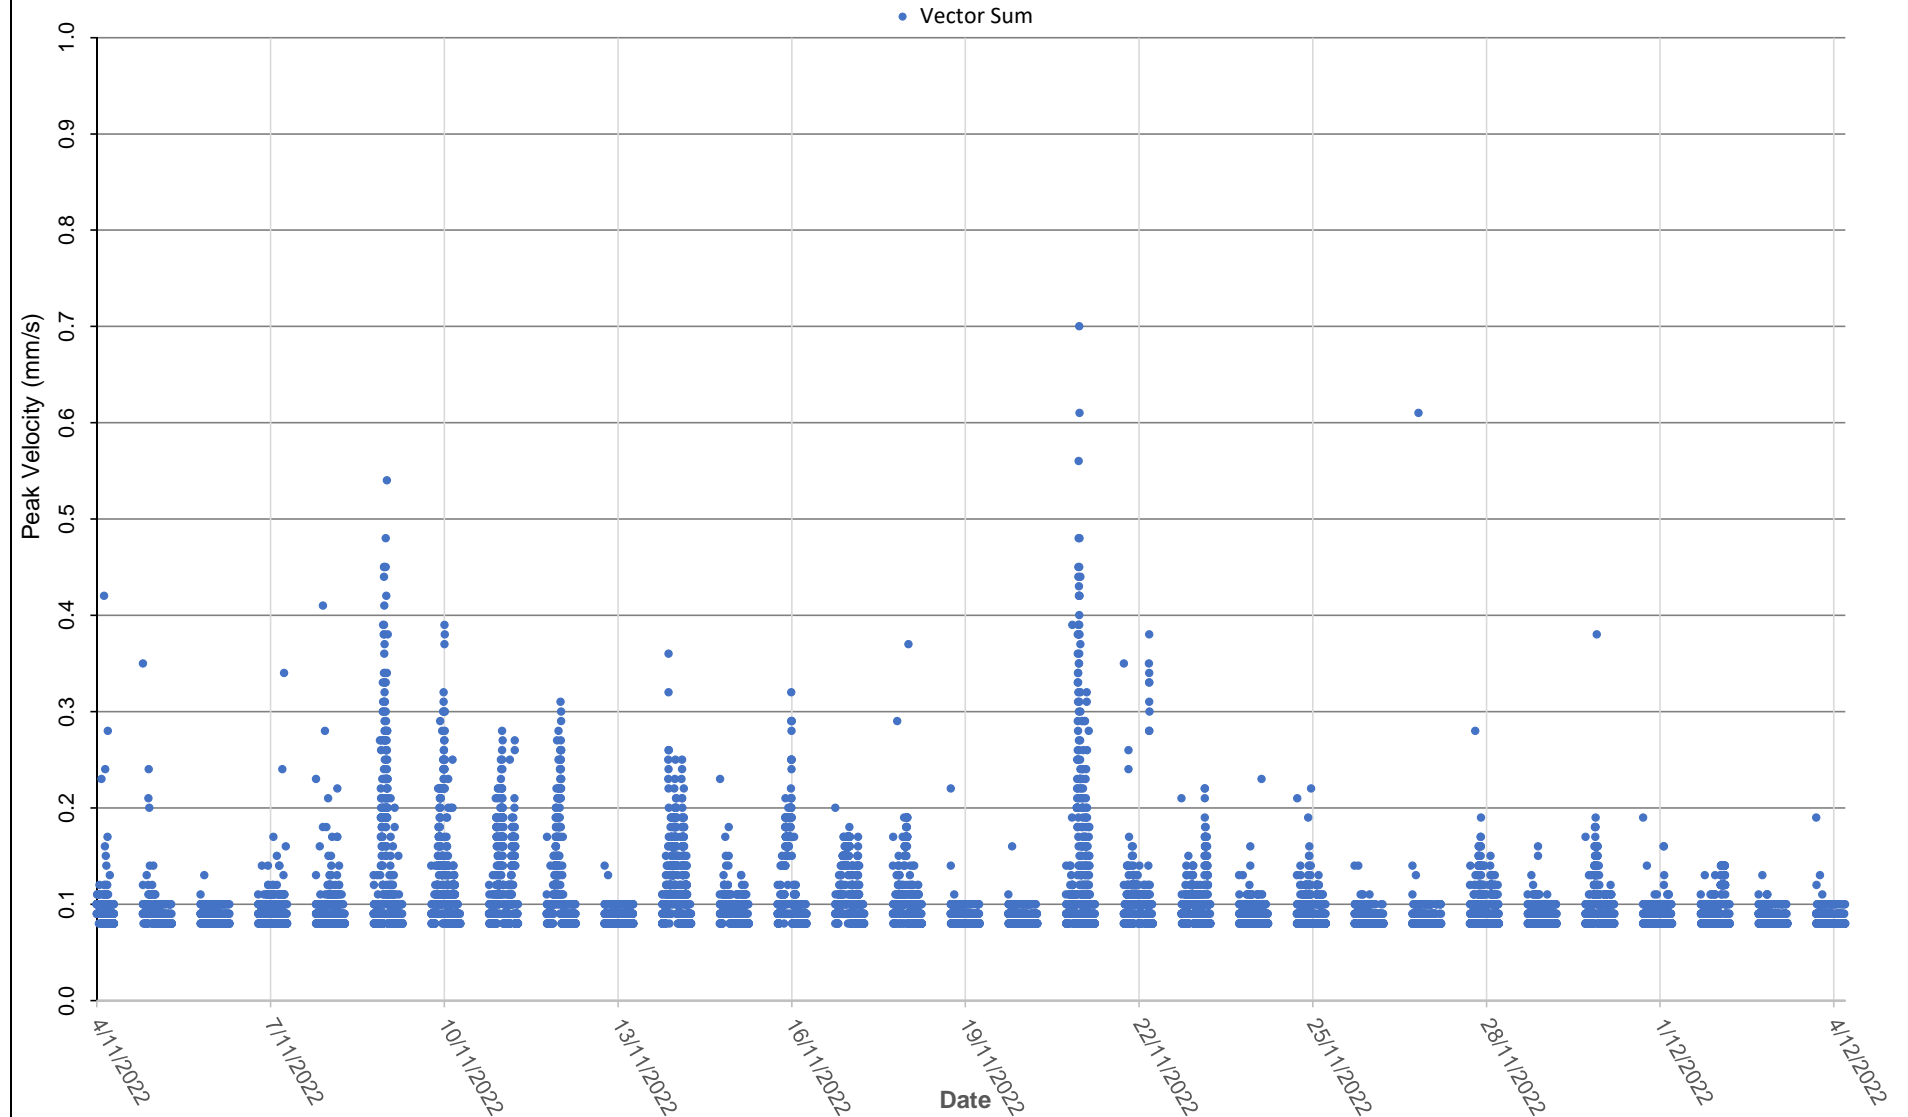
3.1

Note that due to technical issues, VM3-7341 did not record vibrations between 8 October to 4 November 2022. However, considering the low vibrations recorded among other four vibration monitors and its distance away from the excavation, we expect that the vibrations at VM3-7341 locations should not have any exceedance events. The vibration monitor at VM3 location has been replaced by another functional unit (VM3-7352) on 4 November 2022.
